Manhole Inspection Summary

Manhole # S09YY1001MH

Insp Date: **8/2/06 9:09 AM**

Location Address: **2610 WHITNEY AVE**

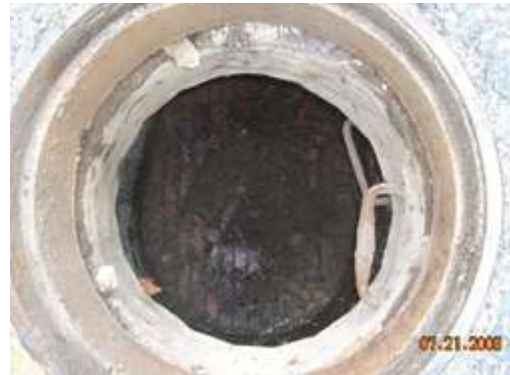
Top View

Corroded steps. Channel debris.

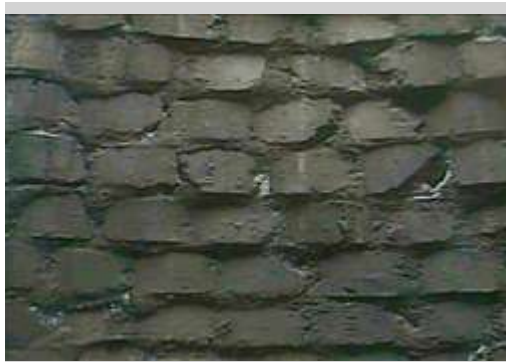
Defect

Barrel deterioration and infiltration.

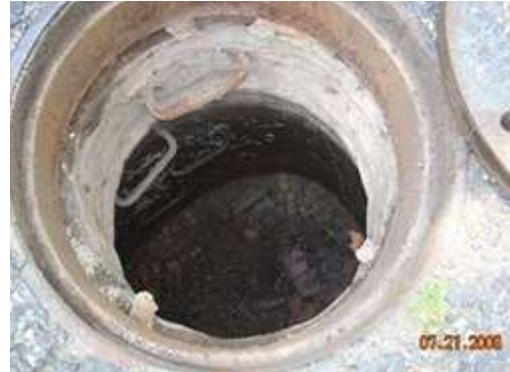
Defect

Frame leaks. Adjustment deterioration, loose brick and infiltration. Barrel infiltration.

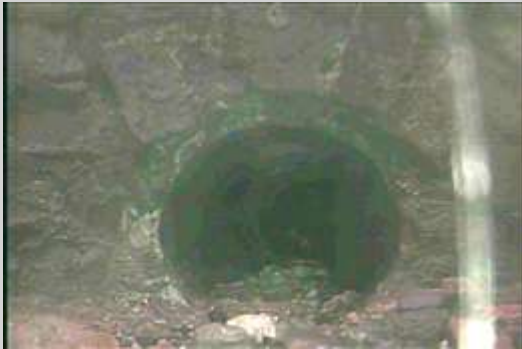
8 in. Circular Gravity Sewer
Pipe Out @ 12 O'Clock

Deposits: ☐ None ☒ **Mud** ☐ Sludge ☒ **Debris** ☐ Grease

Silt Depth: **1** (in.) Deposits Extent: **Light**
